Biological and Water Quality Study of the East and West Branches of the DuPage River and the Salt Creek Watersheds

Cook, DuPage, Kane and Will Counties, Illinois

Technical Report MBI/2008-12-3

Final Report

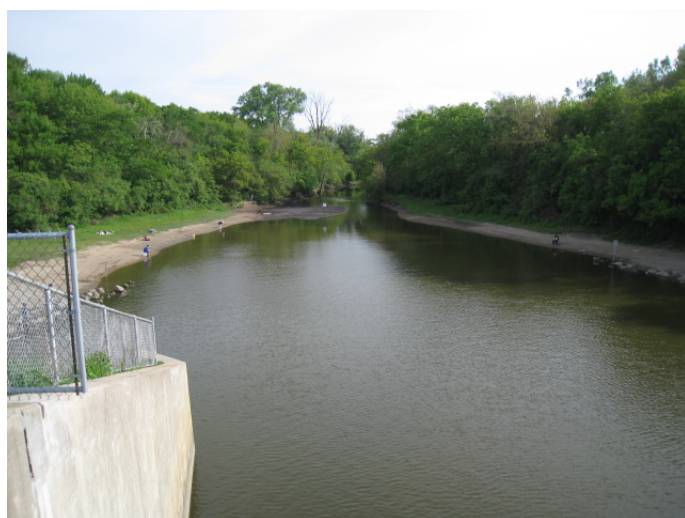
Section of the Busse Woods Impoundment, looking upstream from spillway

Busse Woods Reservoir South Dam: The Busse Woods Reservoir South Dam is located on Salt Creek within the Busse Woods Forest Preserve. The dam is owned and maintained by the Illinois Department of Natural Resources Office of Water Resources and is located within Elk Grove Village. Access is best granted off of Arlington Heights Road to picnic groves 26 and 27 or 32.

The dam was built for flood control and recreational purposes in 1977. The dam is of earthen construction and has a height of 23 feet and is 1381 feet long. The reservoir has a surface area of 415 acres.

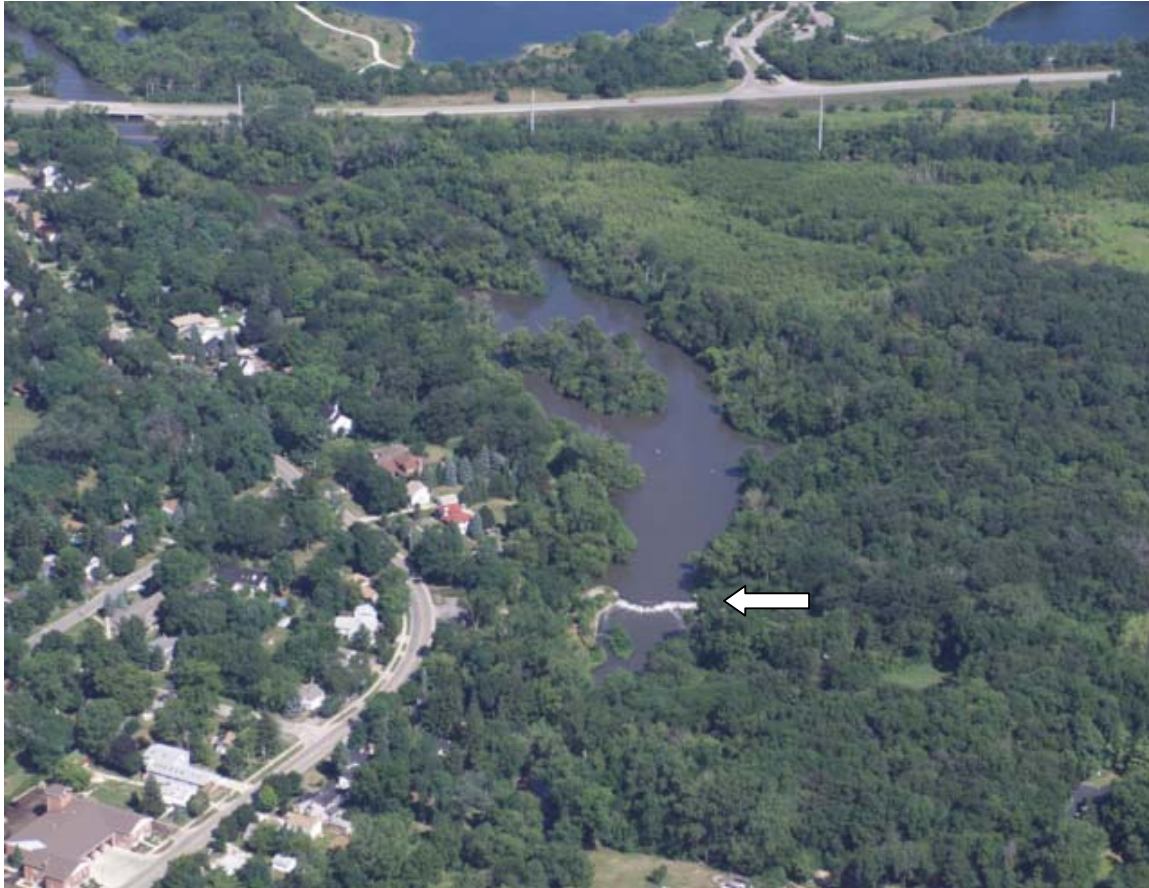
Aerial view of the Warrenville Dam looking upstream (2001). Dam highlighted by arrow.

Warrenville Grove Dam: The Warrenville Grove Dam is located on the West Branch of the DuPage River within the Warrenville Grove Forest Preserve in the Village of Warrenville. The dam is one third of a mile upstream of Warrenville Road. The low head dam is owned by the Forest Preserve District of DuPage County (FPDDC) and is approximately 70 years old. Access to the dam is best gained via the Forest Preserve Parking Lot on Batavia Avenue.

The dam also features a mill race that was partially retrofitted in 1995 to function as a fish ladder and canoe chute. The impoundment created by the Warrenville Grove Dam is approximately 1.2 miles in length and covers about 16.9 acres.

The dam was constructed by the Civilian Conservation Corps between 1936 and 1938. The dam was designed by the National Park Service and was part of a dam building program in the region that was conveyed as a way to “reduce bank erosion”. The site for the dam was chosen due to the presence of an older abandoned dam in the same location that provided a power source to mills between 1847 and 1897.

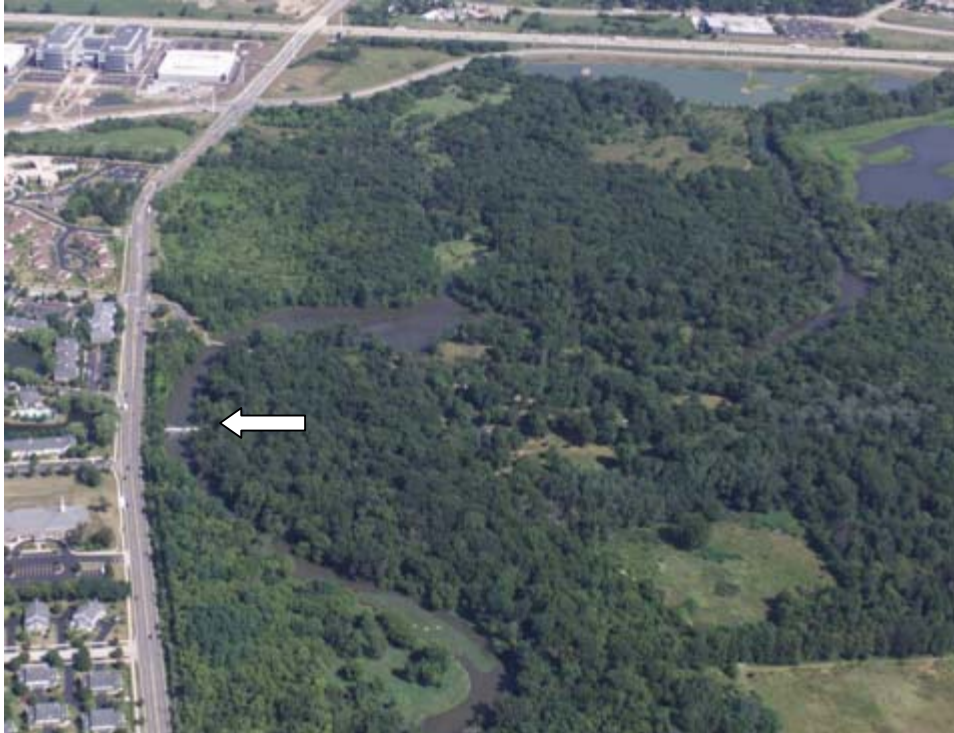
Aerial view of McDowell Grove Dam, looking upstream (2001). Dam highlighted by arrow.
